Rehabilitation of an Old Concrete Lohse Arch Bridge — Replacement of All Hanger of Kimitsu Shinbashi Bridge —

コンクリートローゼアーチ橋の補修 — 君津新橋の吊材取換 —

Synopsis

The Kimitsu Shinbashi Bridge is a Lohse arch bridge with reinforced concrete arch ribs and prestressed concrete deck slab. On October 23, 2008, it was discovered that one of the 40 hangers connecting the arch ribs and deck slab had broken. The bridge was closed to traffic and breaking mechanism was followed by a detailed investigation. Repairs were effected step by step, ensuring the safety of the bridge throughout the process. This report describes the circumstances and procedures leading up to the replacement of hanger, and reports on the hanger replacement work utilizing newly developed tension releasing equipment.

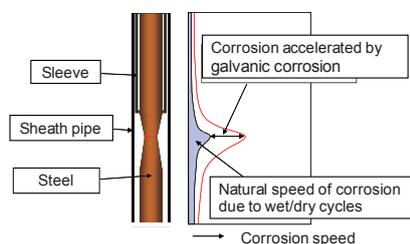
Fig. 3 Corrosion mechanism

From the results of these investigations, it was surmised that the joint between sheath pipes protecting the steel bar separated due to degradation and vibration. In addition, dissimilar metal corrosion occurred due to partial electrical contact between the stainless steel sheath pipe/sleeve and the steel bar, and that the steel bar subject to conspicuous reduction of cross-section lost resistance capacity and had broken. This corrosion mechanism is illustrated in Fig. 3.

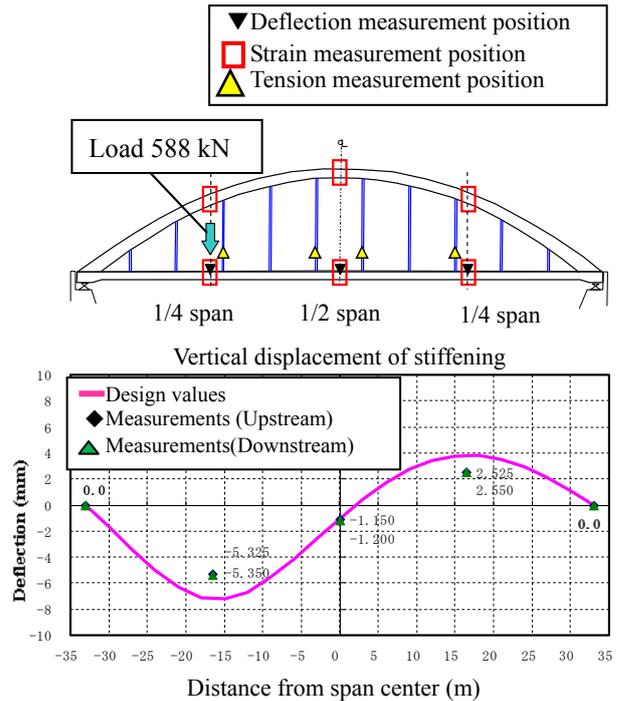
Fig. 8 Results of loading test on bridge after repairs

The results of measurement for the case of loading at 1/4 span are shown in Fig. 8. The graph on the left shows the deflection of the deck slab under load. The measurements of deck slab deflection and strain in the arch ribs and deck slab matched well with the calculated estimates, confirming that the required flexural stiffness and load carrying capacity have been achieved. The distribution of strain in the arch ribs and deck slab was consistent with Bernoulli-Euler model assumptions, confirming that each of the members was behaving as an elastic body.
