# Outline of “Earthquake Damage and Measure to Concrete Poles for Shinkansen”

## 「新幹線用コンクリート製電柱の地震被害とその対策」の概要

## 1. Introduction

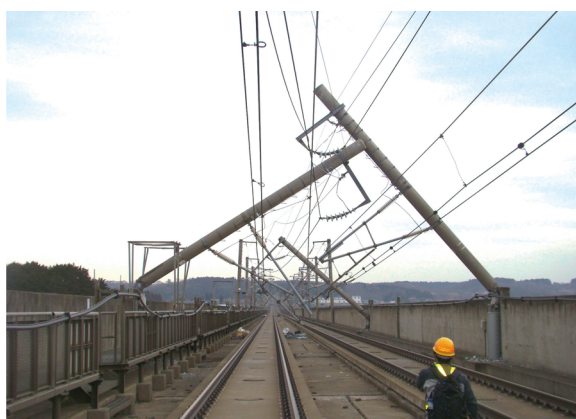
**Fig.1** Damage of poles on the viaduct

The 2011 off the Pacific coast of Tohoku Earthquake caused serious damage on the contact line facilities of JR East. Particularly, many of the concrete poles on the viaduct of Tohoku Shinkansen were broken and/or

Damage of concrete poles is shown in **Fig.1** and **Fig.2**.

Therefore, a seismic retrofitting method was developed to prevent fatal damage such as concrete pole breakage and greatly tilt, and can be restored in a short time.
