# Rapid Reconstruction of the Superstructure of a Bridge Swept Away by Torrential Rainfall in July 2018 — Disaster Recovery Works between the Shingu and Otoyo Interchanges —

平成30年7月豪雨により流出した橋梁上部工の復旧実績  
— 新宮 IC ~大豊 IC 間災害復旧工事 —

*Structure:* 3-span pretensioned prestressed concrete hollow slab bridge

*Bridge Length:* 63.5 m

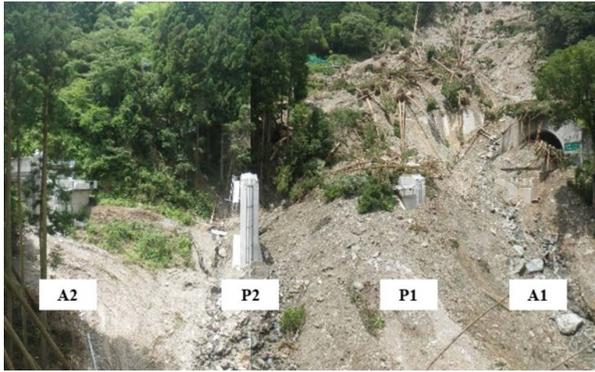
Fig. 3 Damage to the northbound Tajikawa Bridge

In the predawn hours of July 7, 2018, the superstructure of the 63.5-m Tajikawa Bridge on the northbound side of the Kochi Expressway between the Shingu and Otoyō interchanges was swept away by a landslide that started outside of the expressway property. The expressway had been closed because of the rainfall from 18:30 of the previous day; no expressway users were harmed. The collapsed area stretched roughly 320 m from the top to bottom of the hillside and was roughly 90 m in width. The estimated volume of collapsed soil was roughly 45,000 m<sup>3</sup>. The landslide swept the superstructure of the northbound Tajikawa Bridge down the hillside into the Tachikawa River, a Class A river (Fig. 4). Notably, the section of the expressway where the disaster occurred comprises separate northbound and southbound structures; two-way traffic control was implemented on the undamaged southbound side to allow passage in both directions.

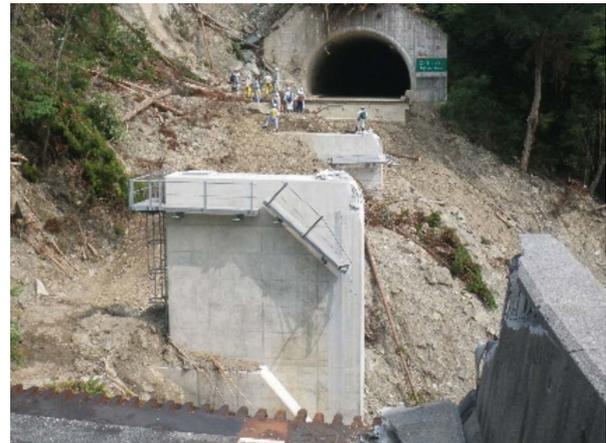
Fig. 5 Remaining substructure of the northbound Tajikawa Bridge

Visual inspections of the remaining bridge substructure (Fig. 5) revealed partial damage at the corners and damage to the bridge accessories, but no significant cracks indicative of structural deformation. Therefore, the reutilization of the substructure was carefully investigated by taking detailed field measurements, and conducting an analytical study to simulate the relationship between the stress history and ultimate strength of the substructure under landslide conditions.

The heights of substructures and distances between them were measured and compared to as-built drawings and design values; no displacement resulting from the landslide was observed. Seismic prospecting was also conducted, revealing that elastic waves propagated from the top of piers and abutments to the tips of piles and that there was no major damage indicative of the destruction of piers, abutments, or piles.

the substructure. The evaluation confirmed that the piers, abutments, and piles were within their allowable stress values under the conditions in all stress histories to a certain degree.

Given the results of the aforementioned evaluation and analytical study, the decision was made to reutilize the remaining substructure as the substructure of the bridge to be reconstructed after performing partial repairs and replacing the bridge accessories.

In areas where corners and other parts were damaged, a water jet chipping was used to remove the outer layers of concrete. Damaged rebar was cut and then restored with enclosed-arc-welded joints. Additionally, nearly all bridge accessories (e.g., bearings, expansion joints, inspection catwalks) were replaced.
