Design and Construction of a Post-Tensioned T-Girder Bridge with Corrugated Steel Webs — Rebuilding of Mito Bridge —

ポストテンション方式波形鋼板ウェブ PCT 桁橋の設計・施工 — 水戸橋架替え工事 —

The Mito Bridge is located in Katsushika-ku, Tokyo, and crosses the class-A Ayase River. The bridge was recently rebuilt into a post-tensioned prestressed concrete (PC) T-girder bridge with corrugated steel webs. The design was determined in consideration of girder depth restriction and weight saving of the superstructure for reduced cost.

Structure: Post-tensioned simple corrugated steel web T-girder bridge

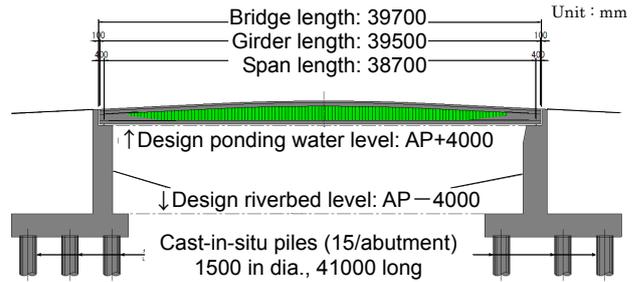
Fig. 1 Structural overview

Table 1 shows the materials used for the bridge. Fig. 1 shows the structural overview, and Fig. 2 shows the girder cross sections.

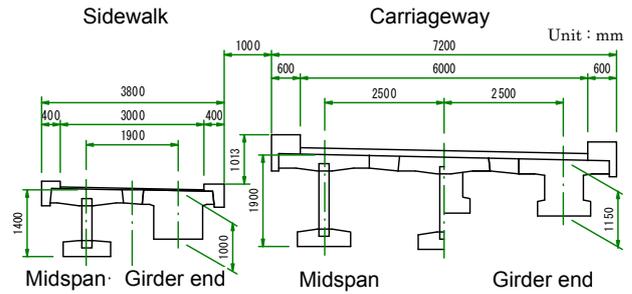
Fig. 2 Girder cross sections

Prestressing tendons in post-tensioned T-girders are bent upward from the midspan toward the supports. Since the corrugated steel webs in this bridge could not accommodate the tendons, the thickness of the lower flange needed to be increased to follow the bend. As a result, the ratio of the corrugated steel web in the main girder cross section decreased toward the girder ends, and the ratio of the upper and lower flanges increased in turn. Corrugated steel web bridges are usually designed with all shear force assigned to the corrugated steel sheets. In this bridge, however, this assumption could affect the safety margin for the concrete flanges where the thickness was increased. Therefore, the authors calculated shear bearing ratios of the upper and lower flanges and corrugated steel sheets for the areas with the increased lower flange thickness, and made shear verification for the concrete flanges as well as for the corrugated steel webs.

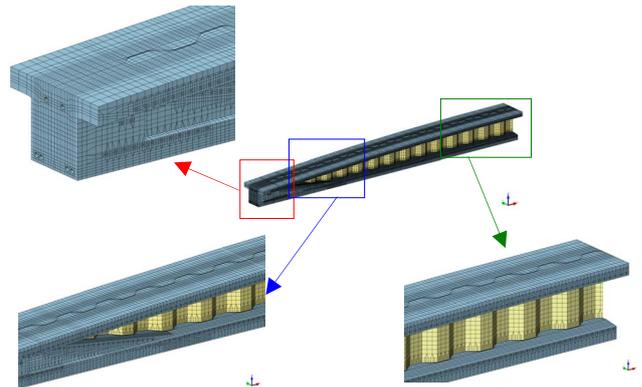
Fig. 3 FEM analysis model

The bending of the prestressing cables starts at the thinnest part of the lower flange. The prestress can cause longitudinal deformation in the corrugated steel sheets. In order to investigate these effects, the authors carried out FEM analysis using a half-span model of the main girder shown in Fig. 3, with the focus placed the stress occurring in the lower flange concrete under the self-weight and prestress.

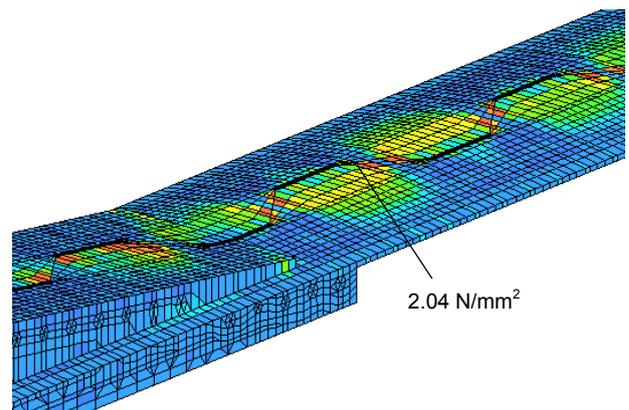
Fig. 4 Principal stress distribution in the lower flange

Fig. 4 shows the analysis result. Tensile stress of about 2.0 N/mm^2 occurred in the top edge of the lower flange. This likely indicates that a force is generated in the lower flange concrete to separate from the embedded corrugated steel sheets due to not only the contact pressure of the prestressing cables but the out-of-plane deformation of the steel sheets due to the longitudinal prestress as shown in Fig. 5. However, it was concluded that no cracks would occur under a tensile stress of 2.0 N/mm^2 because cracking strength of the lower flange concrete was estimated to be about 3.0 N/mm^2 from the design concrete strength of 60 N/mm^2 . No cracks were observed in actual construction at the locations in concern.

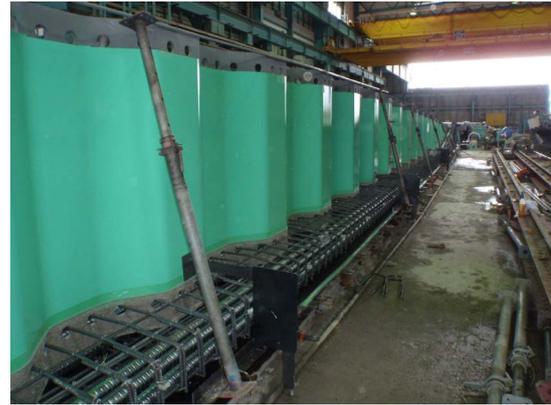
Fig. 6 Main girder manufacturing

of the main girders to make the conditions during manufacture as equal as possible to those during connection at site. The odd-numbered segments (1, 3 and 5) were cast first, and, using their end surfaces as formwork, the even-numbered segments (2 and 4) were cast.

This precast segmental bridge had a girder length of 39.5 m divided into five segments. Unlike concrete web bridges, main girder connection work at site included bolt joining of the corrugated steel sheets as well as steel key joining and cable tensioning. For that reason, a match-cast method was adopted for the manufacturing

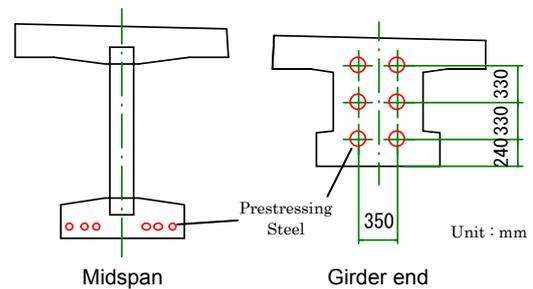
Fig. 7 Prestressing steel arrangements

The longitudinal cables of a corrugated steel web PC T-girder bridge have a laterally eccentric arrangement in the lower flange to avoid the web at the center. Fig. 7 shows the arrangements of the six cables (12S12.7B) in this bridge. Taking the low lateral rigidity of the corrugated steel web structure into account, the cables were tensioned symmetrically and simultaneously at both ends using four jacks to prevent eccentric force from acting on the cross section during tensioning (Fig. 8). The lateral spacings of the cable anchors need to be determined to allow for simultaneous use of two jacks.

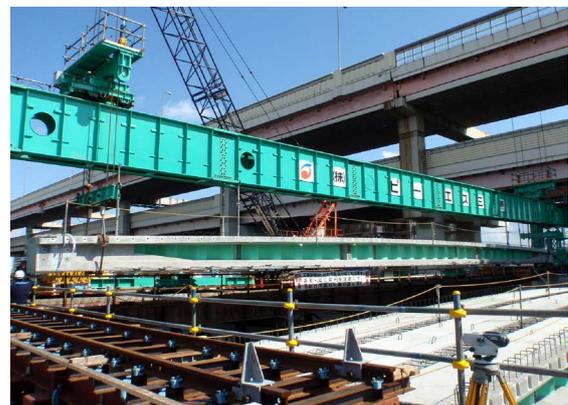
Fig. 9 Main girder erection

Fig. 9 shows erection of a main girder, and Fig. 10 shows the schematic of the erection operation.

The bridge was close to the Metropolitan Expressway on the left bank and a residential area on the right bank. Work space for girder erection was limited to a temporary pier which was built in the river. Therefore, an erection girder and rails were installed at the back of the abutments for lifting and moving the main girders to the positions.

The main girder erection was completed in a period of ten days, with one day for conveying, positioning and connecting the segments and tensioning the cables, and

one day for lateral transfer and erection of the girder for each of total five main girders.
