Construction of Space Truss Bridge — Nagata Bridge —

スペーストラス橋の施工 — 永田橋 —

This paper reports remarkable points on the structure and technical examinations of Nagata Bridge.

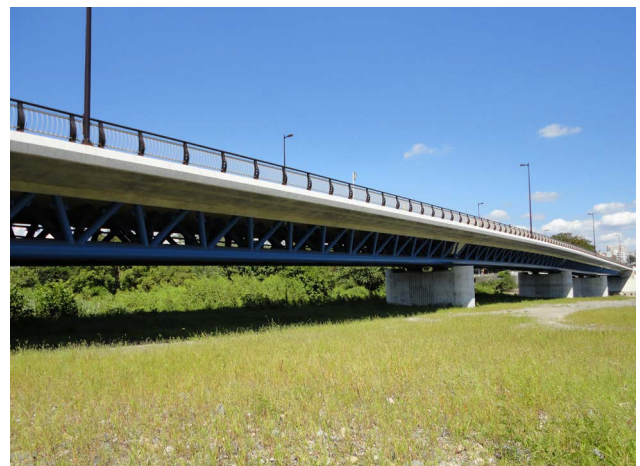
Fig. 1 The whole view

Nagata Bridge, crossing over the Tama River, connecting Fussa City and Akiruno City in Tokyo, Japan, is a four-span continuous pre-stressed concrete composite truss bridge that employed a special structure called “space truss” for the first time in Japan (**Fig. 1** and **Fig. 2**). The bridge must have been completed in only one dry season of the Tama River, which is only 7 months. Due to the tight construction schedule, assembling tests were repeated beforehand in order to eliminate any waste of reassembling or nonconforming works to shorten the actual construction period.

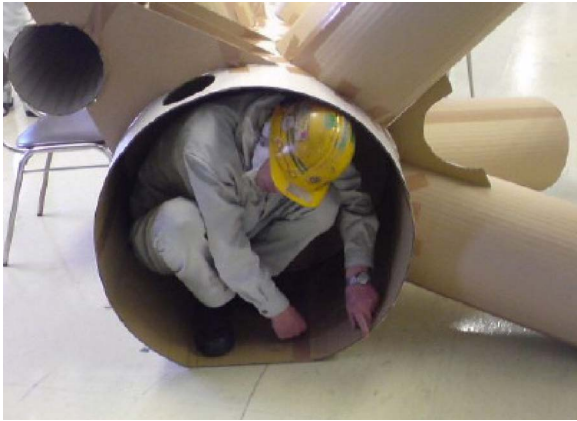
Fig. 4 Simulation of workability

To ensure the good welding quality, the joints of lower members were welded from inside of the pipes. However, the pipes' diameter was 800mm at outside and 666mm in inside, it was impossible for welding operator to freely move and handle the welding instrument inside such narrow pipe as shown in Fig. 4. Due to this problem, welding must have been done from outside attaching the backing metals inside the pipe. In this case, as it was impossible to confirm the quality condition of the welding from inside, fatigue loading test must have been implemented to appraise the accurate toughness of durability of the welded joints.

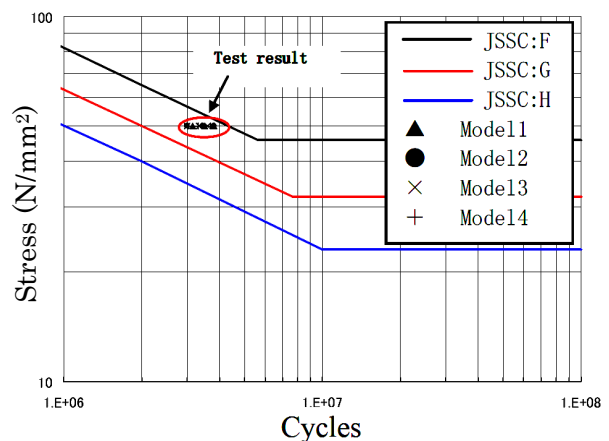
Fig. 6 Result of repeated loading test

Fig. 6 shows the results of repeated loading test. After 1.5 million times of loading, a short crack occurred near the welding zone on Model 3 and Model 4, although all of test pieces were not broken even after over 3.0 million times repeated loading test. All of the results of repeated loading test are above the grade G line and almost close to the grade F line.

According to the above results, durability grade of this method was not less than the grade G.
