Replacement of Existing Steel Trestle Bridge with Concrete Bridge — New Amarube Bridge —

鋼トレスル橋からコンクリート橋への架替え — 新余部橋りょう —

New Amarube Bridge (Fig.1) is a railway bridge located between Yoroi and Amarube on Sanin line of West Japan Railway Company. This bridge adopted 5-span continuous prestressed concrete box girder extradosed bridge, with length 310m and maximum pier height 40m.

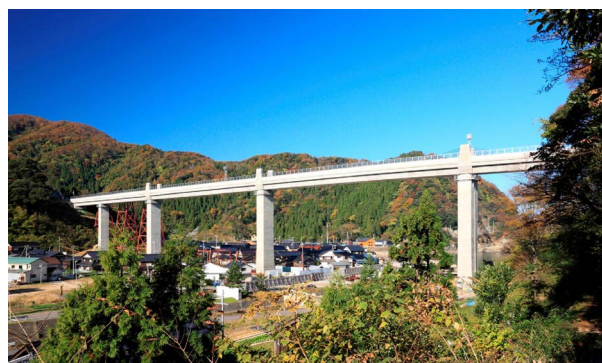
Fig.1 New Amarube Bridge (2010-)

Structure: 5-span continuous prestressed concrete box girder extradosed bridge

Bridge Length: 310.6m

Span: 50.1 + 82.5 + 82.5 + 55.0 + 34.1m

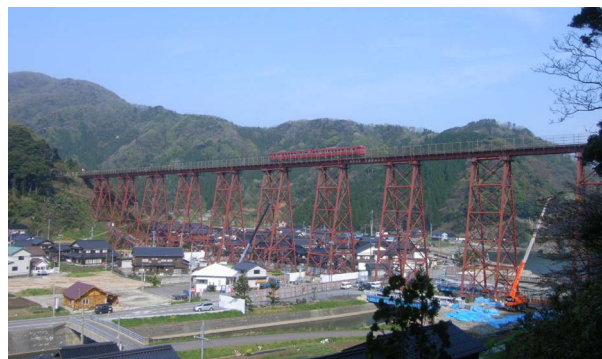
The previous Amarube Bridge (Fig.2) had endured severe winter climate for about 100 years owing to devout maintenance. But frequent service delay and cancel caused by the limitation of wind velocity had severe effect on daily commuting. Because of these circumstances, Amarube Bridge was rebuilt to improve safety and punctuality of transport.

Fig.2 Amarube Bridge (1912-2010)

The previous Amarube Bridge built on March 1912 was the biggest steel trestle bridge in the East then. But huge effort to maintain the bridge had been paid

because its location is near Sanin coast line (about 70m) which has very strong winter wind and the bridge's corrosion spreads very rapidly. And after the train tumbling accident caused by the unique blast in winter 1986, the limitation of wind velocity lowered from 25m/s to 20m/s in 1988 and the service cancel and delay increased a lot. On this occasion, "The Council of Amarube bridge" was established in 1991 and decided to reconstruct the bridge in 2002. The reconstruction work started in March 2007 and the operation started in August 2010.

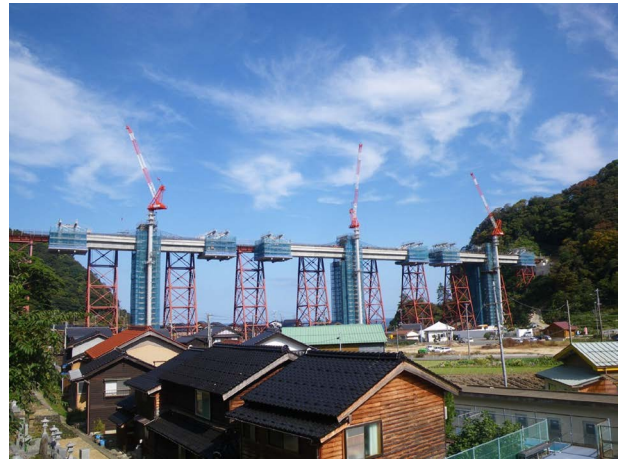
Execution method of superstructure was cantilever erection method at P1 to P3 (Fig.6). The closure pour between P1 and P2 was executed by suspended scaffolding method. At A2 side span, staging erection with temporary bent supports and truss beams was adopted.

Fig.6 Cantilever construction at P1 to P3

The new bridge and the previous one apart only 7m at center line, while cantilever erection, the distance of

form traveler and the existing bridge is just 30cm.

To avoid the collision between form traveler and existing pier by strong wind, analysis of stability of form traveler against wind was done. The condition of analysis of maximum instantaneous wind velocity was 58m/s.

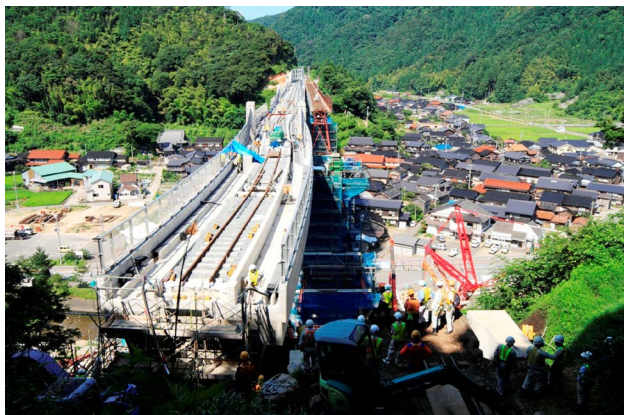
After removing the previous bridge along interference section, at 40m high from ground, bridge girder was slid horizontally and rotated 5.2° around P1 pier axis (Fig.8, 9 and 10). Then, closure part between P1 and P2 was poured to connect.

Fig.8 Before sliding of girder

This girder was about 93m in length and 38,200kN in weight. Reaction forces to A1 abutment and P1 pier were 4,900kN and 33,300kN, respectively. Sliding and rotation of box girder with such heavy

weight and weight balance had never been executed before. To assure the construction reliability and safety, experimental model test and numerical analysis had been conducted beforehand to reflect to the in-situ execution plan^[3].

Finally, girder sliding and rotation was succeeded and the gap of center line of bridge was less than 10mm.

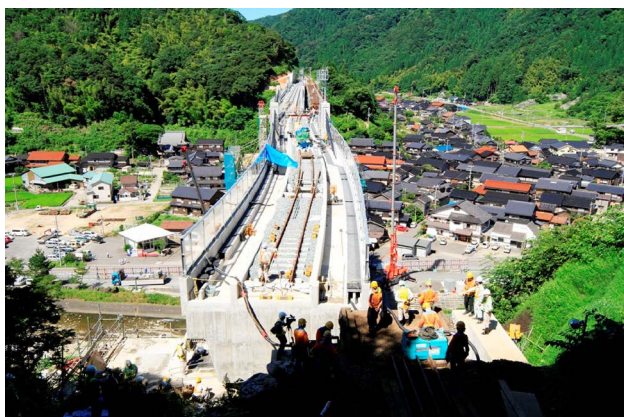
Fig.9 After sliding of girder

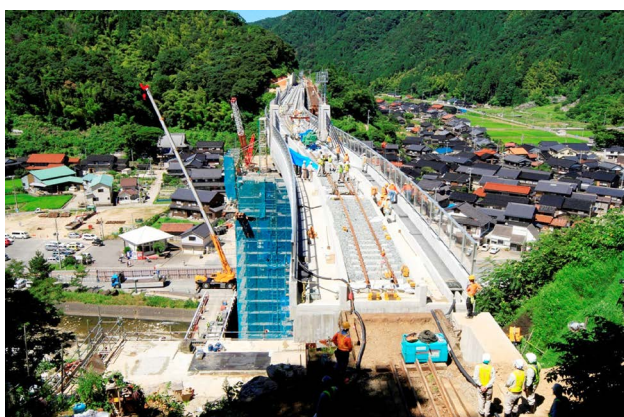
Fig.10 After rotation of girder

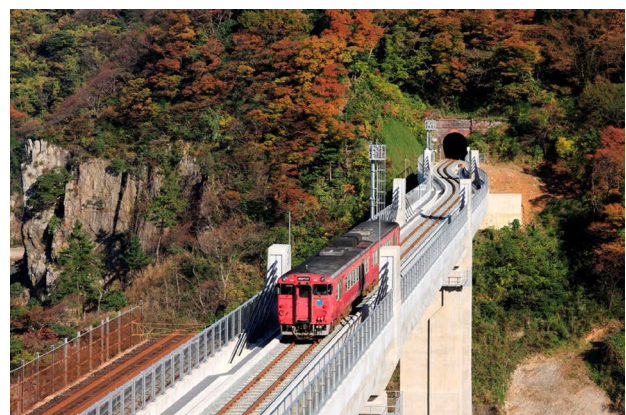
The new bridge is 5-span continuous box girder extradosed bridge with wind protection walls (Fig.11). Bridge replacement work beginning in Mar. 2007 was conducted under extreme condition with severe environment particular to this district where monsoons and heavy snowfall occur. Numerous difficulties were overcome during construction and in particular, thorough measures were taken prior to the final phase of sliding and rotation work of bridge girder. Consequently, the first train was able to cross the new bridge in the early morning of Aug. 12, 2010.

Fig.11 New Amarube Bridge (2010-)
