# Seismic Retrofit of Hamana Bridge

## — Seismic Retrofit Technology for Large Bridges —

### Structural Data

**Structure:** 5-span continuous hinged rigid-frame bridge  
**Bridge Length:** 631.80m

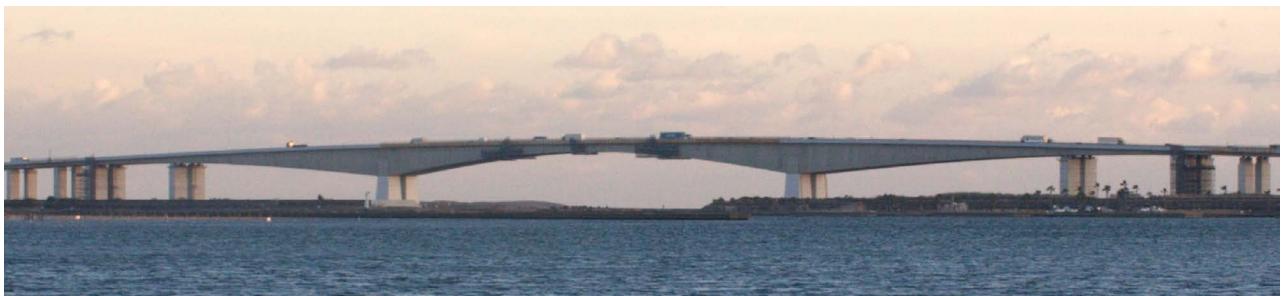
**Fig.1 Current view of the Hamana Bridge**

The seismic design of the Hamana Bridge is based on the Recommendations for Seismic Design of Highway Bridges (1972)<sup>[3]</sup>. The seismic performance of the integrated central-hinge section was checked against the Level 2 earthquake ground motion specified in the current Specifications for Highway Bridges and the estimated ground motions of the anticipated Tokai, Tonankai and Nankai earthquakes. As a result, it was found that the superstructure and piers of the bridge would not satisfy the specified seismic performance requirements. It was thus decided to reinforce the superstructure with carbon fiber sheets and strengthen

the piers by steel plate or concrete jacketing (**Fig.1**).

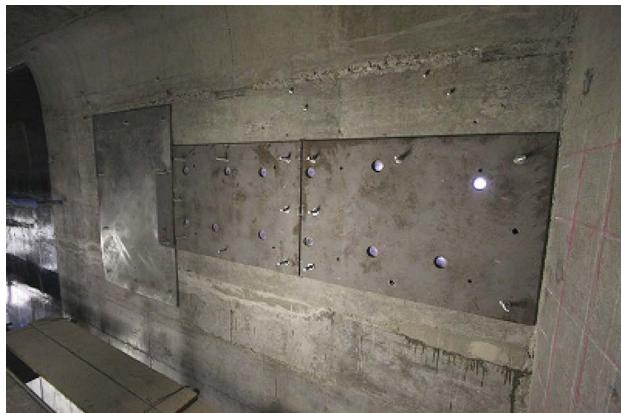
**Fig.2 Locations of drilled holes in girder web**

In order to rigidly connect protruding anchor blocks to the existing girder webs, holes for prestressing tendons were drilled by using a core boring machine. Hole locations were determined by using a reinforcing bar detector and an X-ray scanner so that re-bar and PC tendons of the existing girder would not be damaged. In cases that holes could not be drilled at design locations, hole locations were altered as appropriate in view of factors such as hole spacing, the distance from the edge, and the locations of the steel members of the protruding external-tendon anchor blocks to be installed later (**Fig.2**).

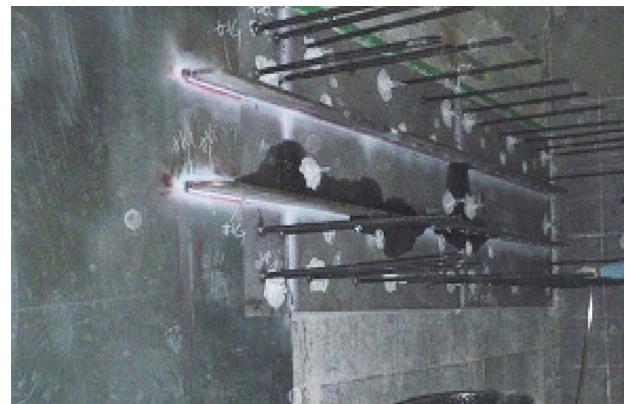
**Fig.3 Epoxy resin grouting**

Steel plates were installed for reinforcement against the tensile stress acting on the girder due to the tension of the external tendons. After these reinforcing steel plates were brought into the girder, they were installed at the specified locations on the existing webs cleaned in advance and were secured in place so as to leave a 5 mm thick space for epoxy resin grouting. Then,

the space between the steel plate and the existing web surface was grouted with epoxy resin to bond the reinforcing steel plate to the existing web. **Fig.3** shows a reinforcing steel plate used for protruding anchor block installation. The reinforcing steel plates for protruding anchor block installation were provided with deformed stud dowels to ensure strong connection between the protruding anchor block concrete and the reinforcing steel plate.

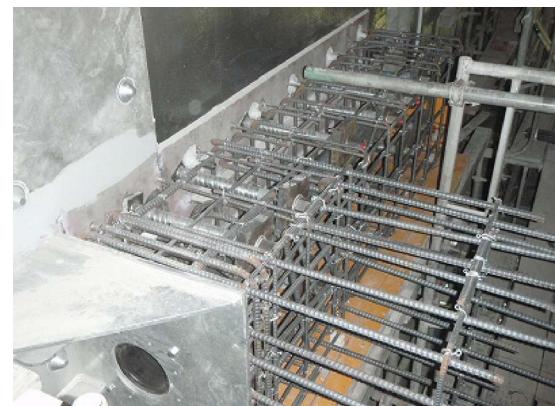
**Fig.4 Reinforcement in anchor block**

The reinforcement pattern for a protruding anchor block is shown in **Fig.4**. One end of each prestressing bars (hereinafter, PC bars) is embedded in the concrete block as a dead anchor, and the tendon is tensioned from outside the girder through sheathing. The tension from the prestressing tendons is used to join together the anchor block and the girder web.

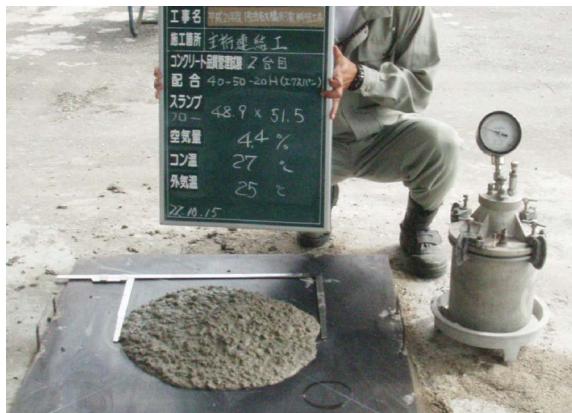
Each external tendon anchor block has anchorage elements, anchorage reinforcing bars, prestressing tendons by which to join together the anchor block and the girder web, and reinforcing bars for struts for reducing girder web deformation due to the tension from the external tendons. The anchor block is heavily reinforced as shown in **Fig.4**. Accordingly it was judged that complete concreting by use of normal slump concrete would be difficult, and it was decided to use 50 cm slump flow concrete<sup>[4]</sup>. **Fig.5** shows the slump flow of the concrete used.

**Fig.5** Concrete with slump flow of 50 cm

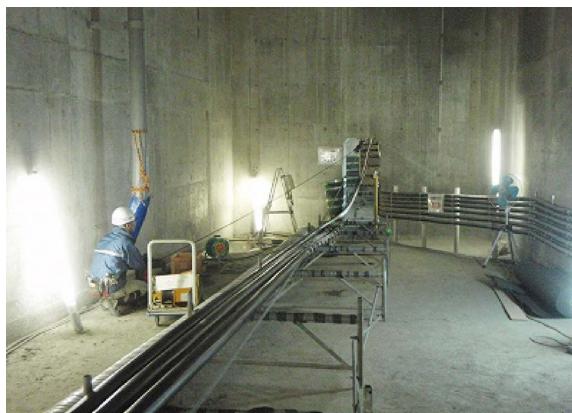
External tendons ( $19 \times \phi 15.2\text{mm}$ ) were inserted into the girder by using a turn table. Temporary cable supports were provided with felt sheets and a roller conveyor to protect the external tendons. **Fig.6** shows external tendons inserting into the box girder.

**Fig.6** Insertion of external tendons into box girder

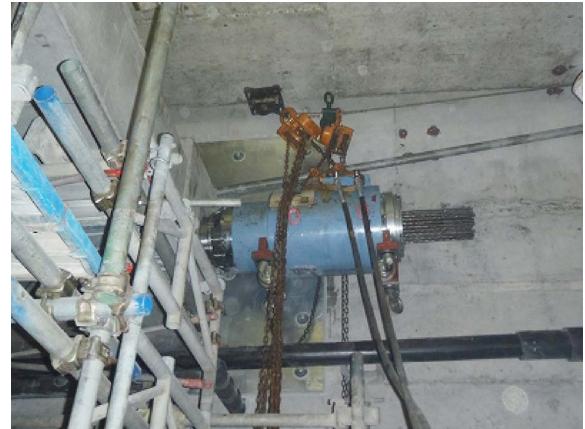
The external tendons were tensioned from both ends. One tensioning team consisted of hydraulic jacks, hydraulic pumps and tensioning crews, the tensioning took longer time than in normal tensioning work because it had to be carried out in a confined space. **Fig.7** shows the condition of tension work in confined space.

**Fig.7** Tensioning work in confined space

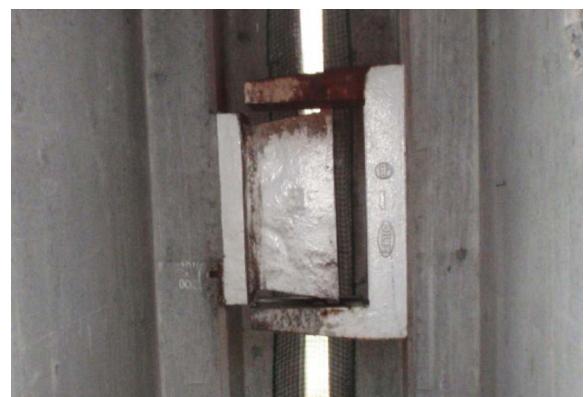
The central hinge had a gap of 100 mm and consisted of restrainers to transfer shear force (**Fig.8**) and rolling leaf type expansion joints. In the central-hinge integration work, the lanes were closed to traffic, and, after the expansion joints were removed, concrete was placed and prestress was transferred by means of external tendons to connect the hinge section rigidly.

**Fig.8** Hinge restrainer

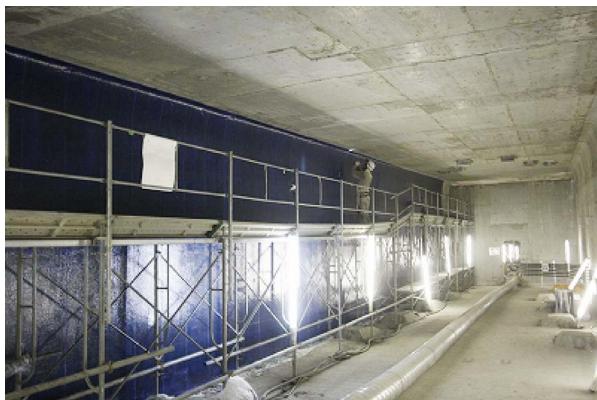
**Fig.9 Carbon fiber sheet reinforcement inside box girder**

Three types of carbon fiber sheets having weights per unit area of 200 g/m<sup>2</sup> (guaranteed tensile strength = 377 kN/m), 300 g/m<sup>2</sup> (guaranteed tensile strength = 566 kN/m) and 400 g/m<sup>2</sup> (guaranteed tensile strength = 755 kN/m) were used, and carbon fiber sheets of each type were bonded in one layer or two layers. Thus, in total, six types of carbon fiber sheet arrangements were used for reinforcement.

The reinforcement was carried out in the following steps: (1) cleaning the surface with a sander, (2) applying epoxy resin primer, (3) leveling the surface by applying epoxy resin putty, (4) applying a subcoat of impregnating resin, (5) bonding a carbon fiber sheet and (6) applying an overcoat of impregnating resin. In the case of two-layer reinforcement, Steps 1 to 6 were repeated again.

To anchor the carbon fiber sheets to the existing structure, embedment-type special anchors for carbon fiber were used. An embedment-type anchor is a

bundle of 40 to 130 carbon fiber strands; one end of an embedment-type anchor is embedded in concrete, and the other end is fanned out and bonded to the carbon fiber sheet surface. **Fig.9** shows carbon fiber sheet reinforcement.
