# Concrete-arch Bridge with Curved Girder to Aid Durability and Maintainability — Agematsu Bridge —

維持管理性・耐久性に配慮した曲線桁を有する RC アーチ橋  
— あげまつ大橋 —

## Synopsis

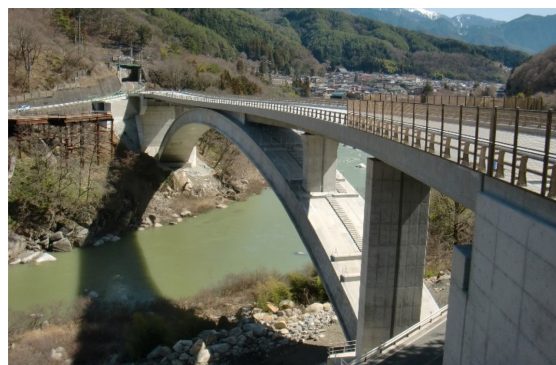
**Fig.1 Agematsu Bridge**

The Kakehashi Improvement Project of which the Agematsu Bridge is a part was carried out to re-route the road to the opposite side of the river to prevent road closures in the event of rock falls or traffic accidents. The bridge is a design-build project integrating substructure and superstructure work with the theme of 100-Year Durable Bridge in Harmony with Nature. The bridge reported on herein is a concrete-arch bridge with a curved stiffening girder. Particular consideration is given to durability, maintainability, and aesthetics within the landscape (**Fig. 1**).

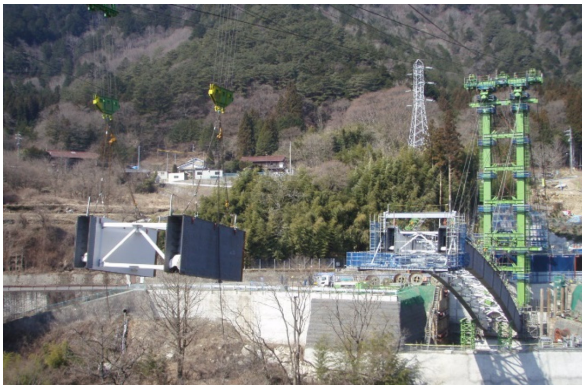
Fig.5 Erection of steel member

The steel member was fabricated as two main box girders divided into 27 blocks with a standard block length of 6.0m. The weight of the main truss for one block of the steel member was 9.0t. The steel member

was erected using the cable erection method, making use of the existing cable crane equipment.

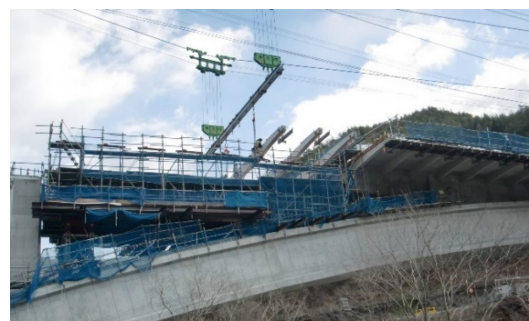
Fig.7 Installing the horizontal ribs

The construction procedure for the stiffening girder is shown in Fig.6. After installing the falsework for the bottom flange, webs and horizontal ribs at the top of the arch rib, the factory-fabricated horizontal ribs were secured in their positions (Fig.7). Then, the web and bottom-flange reinforcements and their formworks were assembled, after which the concrete for the web and bottom flange of the box girder was cast in place. Next, the precast panels were laid out on top of the horizontal ribs. Reinforcement and prestressing tendons were assembled, after which the deck slab was cast in place. Construction was made easier because no falsework was necessary for the cantilever deck slab using this method.
