# Gerber-hinged Prestressed-concrete Box-girder Made Continuous — Suzuta Bridge —

Suzuta Bridge on the Nagasaki Expressway is a 7-span continuous rigid-frame prestressed-concrete (PC) box-girder bridge that has a distinctive hinged structure (a Gerber hinge) at a point a quarter of the way along the center span. The bridge was observed to have deteriorated because of the alkali silica reaction (ASR), with markedly advanced deterioration around the hinged section, which takes in large amounts of water from the bridge deck.

The work reported herein involved a radical repair to cut, remove, and recast part of the main girder near the hinge to remove the hinge and make the girder continuous. While the main girder was removed, structural safety of the whole bridge was ensured by temporary struts and temporary tendons to hold the girder in position.

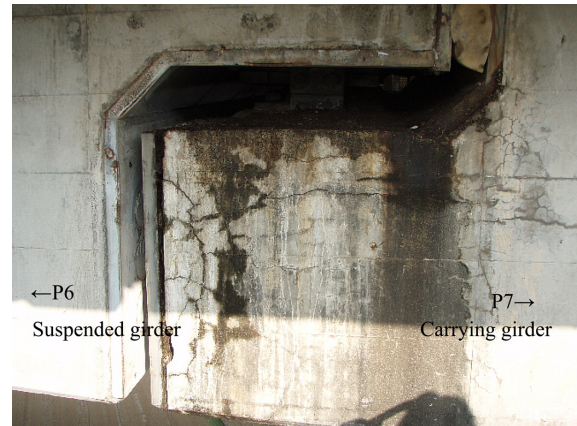
**Fig.4 Cracks (2009)**

After completion in 1978, cracks appeared in the bridge, particularly in the vicinity of the hinge. Detailed surveys conducted from 2004 onwards reported suspected ASR based on the state of the deterioration (Fig.4). In 2010, a detailed survey was performed, including a residual expansion test (Canadian method), polarized-light microscope identification, and electron-probe micro-analysis. This confirmed the presence

of aggregates and swelling that contributed to ASR in the bridge concrete. Because the hinged section had a narrow crank shape, ASR was believed to have progressed rapidly because of water leakage from the damaged expansion joint and ready accumulation of dust in the area.

Because ASR is expected to progress on this bridge, a radical repair was planned to remove the concrete in the vicinity of the deteriorated hinged section, recast with new concrete, and install external cables to make the structure continuous.

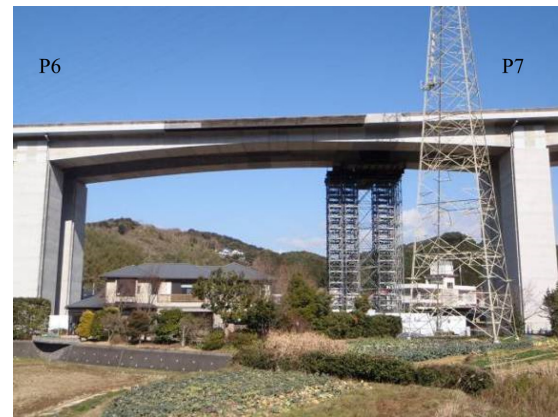
**Fig.8 Temporary struts and tendons**

Under dead load, an internal force of 3,000kN acts on the hinged support, with a downward force on the carrying-girder side and an upward force on the suspended-girder side.

Thus, when the hinged support was removed, the carrying-girder side would tend to rise up while the suspended-girder side would tend to droop, impairing structural stability. To counteract this, the suspended girder was supported by temporary struts and the

carrying girder was held in position by temporary tendons anchored to the ground until the superstructure was made continuous.

Fig.7 shows the overall construction procedure. First, the temporary struts and tendons were installed. The temporary struts on the suspended-girder side consisted of 16 columns with a yield strength of 60tf each.

The member was assembled by stacking up basic assembly units one level after another. H-beams were laid on the topmost level to act as a working stage (Fig.8).

For the temporary tendons on the carrying-girder side, four fabricated polyethylene-coated prestressing tendons with an ultimate load of 2,700kN were used. Anchored to the ground at one end, the tendons passed through the box girder and were anchored to the superstructure at the top of the bridge deck.
