# Design and Construction for Replacement of Deck Slab using High Strength Lightweight Precast PC Slab — ICHIKAWA OHASHI Bridge on BANTAN Access Road —

The existing reinforced concrete (RC) slab of the Ichikawa Bridge was replaced due to remarkable deterioration caused by chloride attack by deicing salts in addition to damage with aging. A high strength lightweight precast prestressed concrete (PC) slab with a two-way PC structure, “HSL Slab,” was selected as the replacement slab to reduce the load on the steel main girder and piers by slab weight reduction and minimize cracking under the severe environment due to deicing salt. This report describes the preliminary study of design and outline of the construction.

Structure: single-span steel composite plate girder bridge

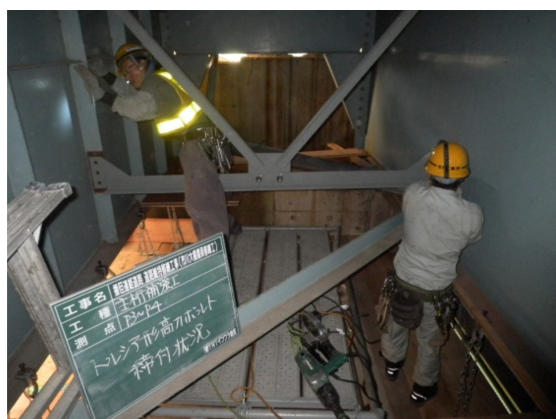
Photo 1. Installation of additional intermediate sway

Constructions of precast PC slab were performed by advancing a rafter crane and transport trailer on the bridge. The target bridge was a composite structure. However, during replacement of an existing RC slab, the slab is cut by a concrete cutter, and the load bearing capacity to support this heavy equipment must be secured by the steel main girder only. Therefore, stress verification was performed with a grid-frame model assuming load sharing by only the steel girder as a non-composite structure. It shows that the flexural compressive stress of the upper flange exceeded the design value.

external cables to increase the main girder bearing capacity were considered, however installation of additional intermediate sway bracing was adopted from the viewpoints of workability and economy. The installation work is shown in **Photo 1**.

The allowable flexural compressive stress of the compressive flange of a steel main girder is reduced by buckling. Increasing the number of sway braces reduced the distance between the fixed points of the compressive flange against buckling by half, and thereby increasing the allowable flexural compressive stress<sup>[1]</sup>. Because the additional sway braces also increase the load bearing capacity in normal service, the braces were retained after construction.

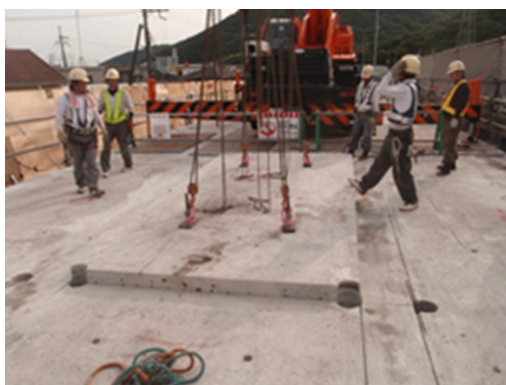
Photo 2. Removal of intermediate deck sections

Because removal of a composite structure slab by the jack-up method, etc. is difficult due to the large number of stud dowels, the intermediate slab sections were removed first. **Photo 2** shows the removal work. After slab removal, the remaining concrete on the girder flange is normally chipped with a breaker. However, the following problems arose in this project.

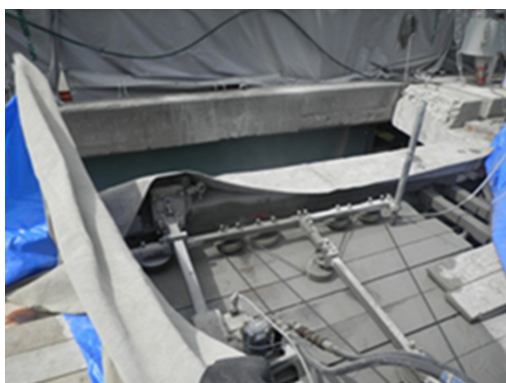
Photo 3. Cutting with wire saw  
(upper surface of flange)

- 1) Chipping was extremely difficult due to concrete and reinforcing steel around the dowel heads.
- 2) Care was necessary to avoid damaging the flange with the breaker tip, causing a concern of schedule delays and labor use exceeding the plan. Therefore, we applied the method that the concrete on the flange was cut horizontally with a wire saw, as shown in **Photo 3**. Cutting on one girder (4.5m axial length) was completed in about 2 hours. As a few cm of concrete remained on the flange were chipped using a chipper with a flat chisel. The dowels were then cut with a face cutter, and the flange surface was prepared with a baby sander. This had the following advantages.

- 1) Since parts cut with the wire saw can be removed as lumps of concrete, there is no fine chipping debris and cleanup time is reduced.

- 2) The risk of damaging the girder flange is greatly reduced by using a flat chisel.

- 3) Chipping efficiency is improved because the dowel heads are cut.

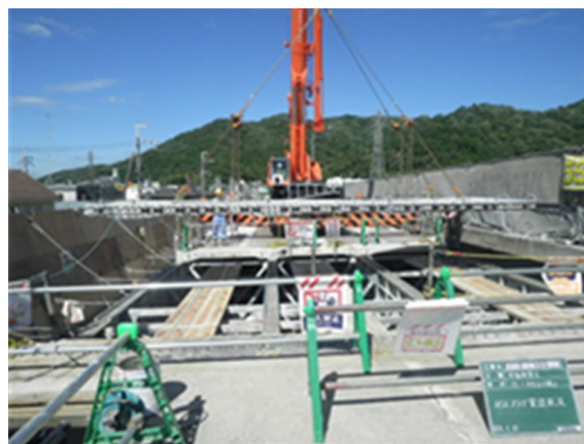
Photo 4. Installation of lightweight PC slab

The slab installation work is shown in **Photo 4**. Installation of two slabs required about 1 hour. Slab transportation was arranged so that construction could begin immediately at the start of work, and the process from slab installation to movement of the crane and steel plates to the next section was completed before noon. In the afternoon, cutting/removal of the intermediate slabs was completed, and preparations were made to cut the concrete on the girder flange the following day.
