Katsushima Area Viaduct on the Metropolitan Expressway Haneda Route (Route 1)

首都高速 1 号羽田線 勝島地区橋梁

Keywords: prestressed concrete bridge, Gerber hinge, external tendons, renovation

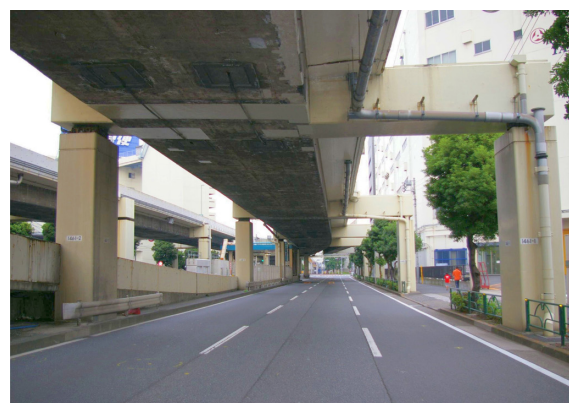
The Metropolitan Expressway Haneda Route (Route 1) is one route of the urban expressway system built for the 1964 Tokyo Olympic Games. The viaduct that is the focus of this project has been in service for over 50 years since opening in 1963. Originally a Gerber bridge with a series of 3-span continuous prestressed-concrete (PC) box girders, it elevates the expressway over a prefectural road (**Fig.1**).

Fig.1 View before renovation

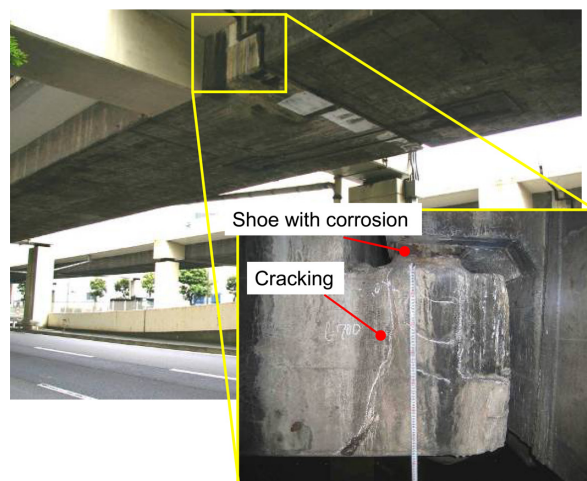
During a periodic inspection, the viaduct was found to have cracks in its Gerber joints and corrosion and other damage in its Gerber shoes (**Fig.2**).

Fig.2 Damage to a Gerber joint

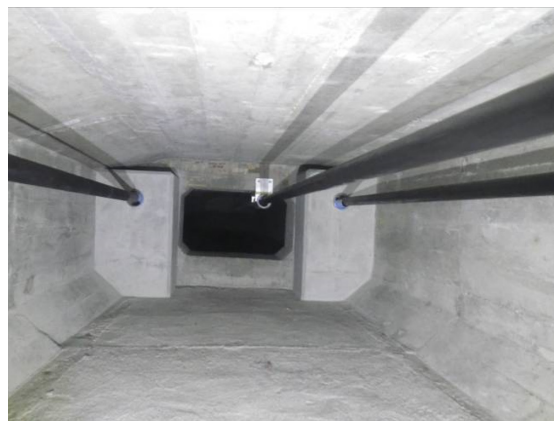
Fig.5 External tendons

bridge. External tendons were used to make the girders continuous over every nine spans (Fig.5). The four continuous girders were separated from each other at their joints to eliminate the Gerber system, with new substructures built to bear the reaction force from the Gerber joints. This combined method was an unprecedented approach for structural improvement of Gerber joints.

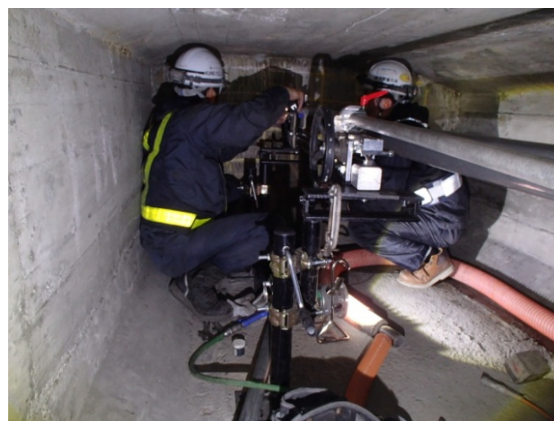
Fig.6 Water-jet drilling

- 1) The gaps between girders were cleaned with water jets before work to make them continuous.
- 2) Transparent formwork was used for mortar injection in the girder gaps to allow monitoring of the filling process.
- 3) Through-holes were made in the cross beams to install external tendons. Water-jet drilling was used to make horizontal holes up to 4,250mm long (Fig.6).

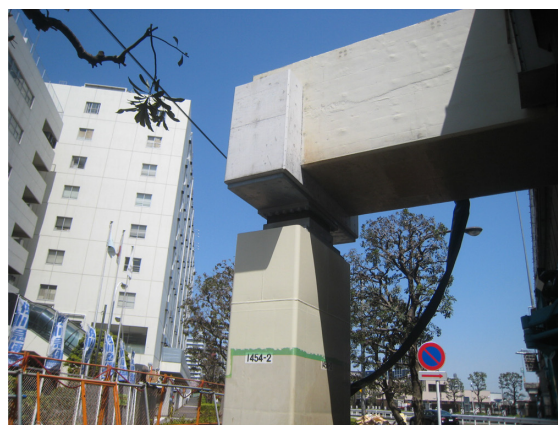
Fig.7 After shoe replacement
(before concrete painting)

- 1) All existing steel shoes were replaced with rubber shoes (Fig.7) following seismic design using an analysis model that simulated the new continuous girder configuration.
- 2) Temporary shoring was installed over the prefectural road on which special traffic controls were implemented. The reaction force (up to roughly 5,000kN) was transferred to the shoring whereupon the existing shoes were cut, removed, and replaced with new shoes.

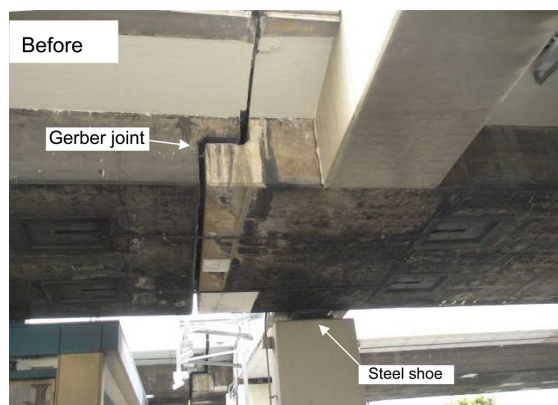
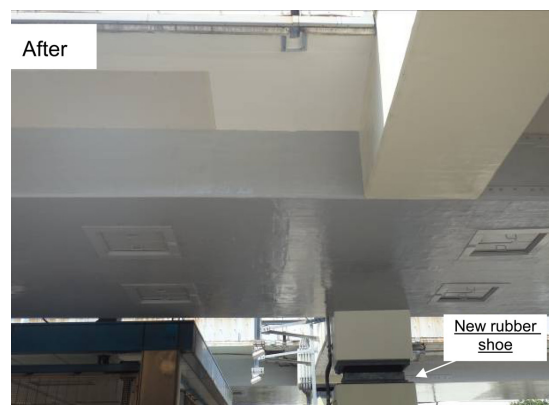
Fig.8 Gerber joints made continuous

(1) Making Gerber Hinges Continuous (Fig.8)

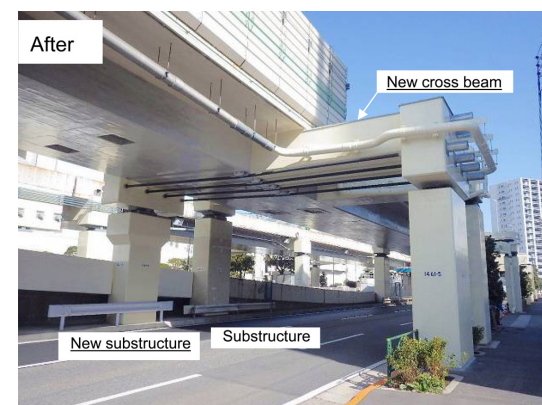
Fig.9 Gerber joints separated with new substructure

(2) Separating Continuous Girders at Gerber Joints (Fig.9)

- 1) The continuous girders were structurally separated from each other at the Gerber joints left at either end. New substructures were constructed below the suspended spans to bear the reaction force of the superstructure. The Gerber shoes were cut using wire saws to structurally separate the girders.
- 2) To ensure safety of the work on the in-service bridge, the reaction force was transferred in a phased manner by measuring the load and displacement during the work and checking the measurements against the design values.

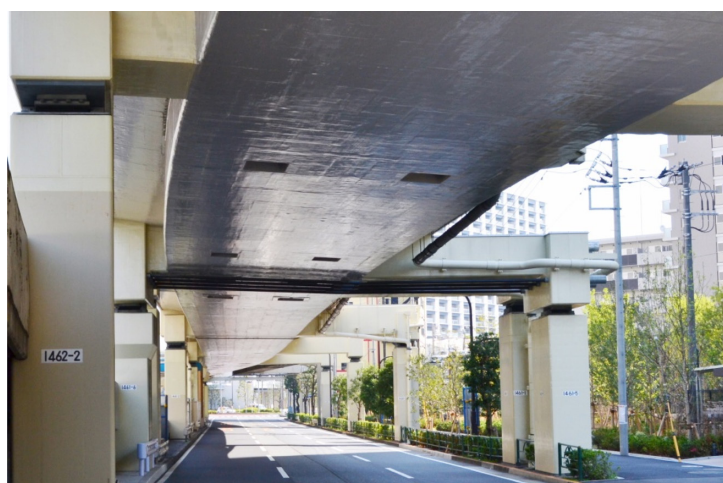
Fig.10 Completion view

The Katsushima Area Viaduct was completed on March 2016 (Fig.10). To extend the life of the Gerber beams and upgrade the performance of the bridge, the Gerber beams were integrated continuously with an external cable system and the existing bearings were relocated. This renovation project won the 2016 Tanaka Award of the Japan Society of Civil Engineers and the 2016 JPCI Award of the Japan Prestressed Concrete Institute.
