# Rapid Reconstruction of the Superstructure of a Bridge Swept Away by Torrential Rainfall in July 2018 — Disaster Recovery Works between the Shingu and Otoyo Interchanges —

平成30年7月豪雨により流出した橋梁上部工の復旧実績  
— 新宮 IC ~大豊 IC 間災害復旧工事 —

*Structure:* 3-span pretensioned prestressed concrete hollow slab bridge

*Bridge Length:* 63.5 m

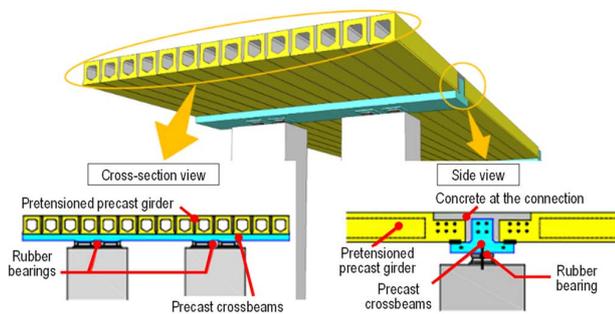
**Fig. 6 SCBR construction method**

In light of the above, the decision was made to use a precast pretensioned hollow girder bridge with the aim of reconstructing the bridge in the shortest possible time. Selecting a precast superstructure presented the option of manufacturing it in a factory while simultaneously repairing the substructure, resulting in a shorter construction schedule. This structure type also involved a lower risk of delays because there is substantially less onsite work than the cast-in-place method. Additionally, the Smart Connected Bridge (SCBR) method was adopted because it would allow the superstructure to be composed of precast components without modifying the existing substructure (**Fig. 6**). In the SCBR method, L-shaped and inverted T-shaped precast crossbeams (**Fig. 7**) are supported by a single bearing line on the abutments and piers, allowing precast girders to be erected and connected in the form of simply supported girders on top of those crossbeams. This eliminates the need to increase the number of bearings to be installed

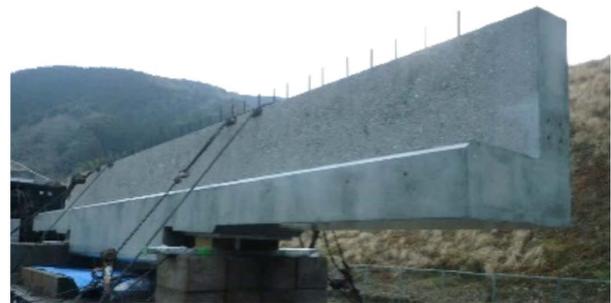
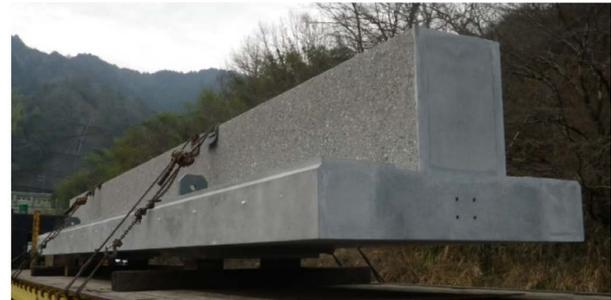
**Fig. 7 Precast crossbeams (top: for abutments; bottom: for piers)**

and to widen the piers at the top to support precast girders, offering advantages in terms of shortening the construction schedule.

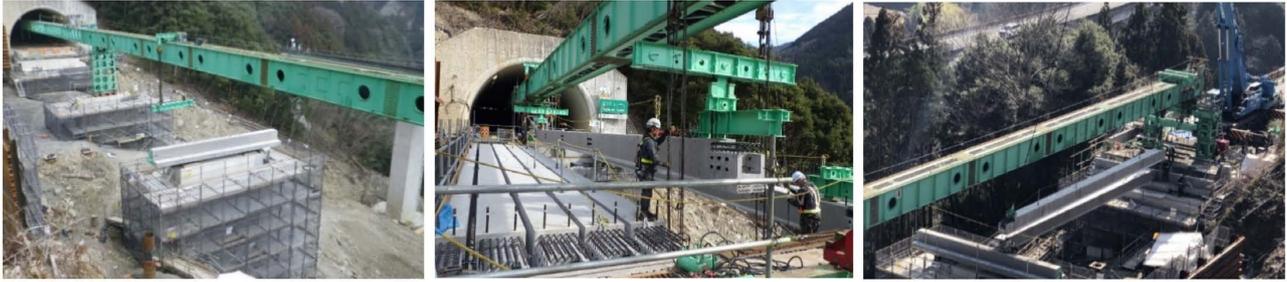
Fig. 8 Installation of precast main girder

Crane erection was possible for the A2–P2 span; therefore, a 200-ton crane was used to erect the span. The other spans were erected with launching girder (Fig. 8). Consequently, the construction schedule was shortened by roughly 2 months compared with that of the previous structure type (Fig. 9). The construction schedule is shown in Table-2.

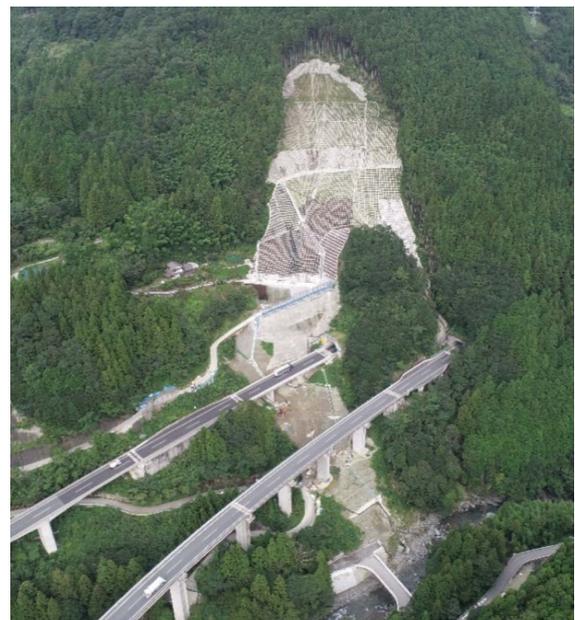
Fig. 10 Panoramic view of the completed recovery works (taken in August 2021)

girders made it possible to complete the work and reconstruct the original four lanes of traffic roughly 1 year after the disaster struck on July 7, 2018 (Fig. 10).
